Northrop T-38

Airworthiness Certification

AIR-230 Airworthiness Branch
Federal Aviation Administration
Washington, D.C.
March 1, 2013

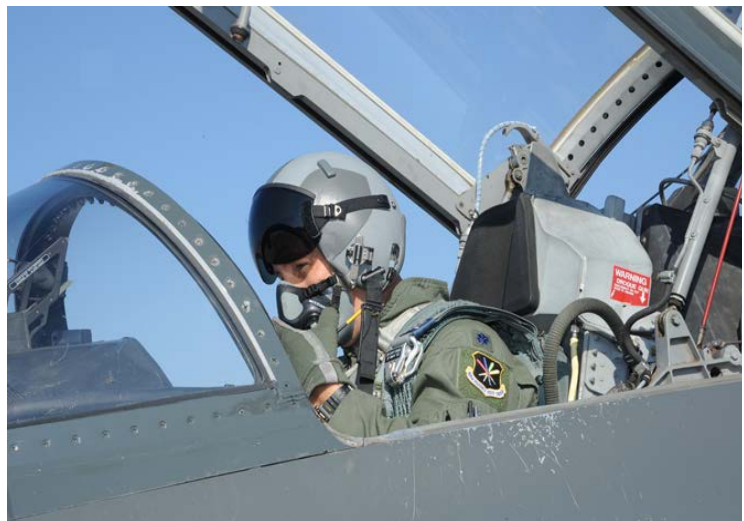
A USAF T-38 instructor in a T-38C. Note that this aircraft retains its original Northrop ejection seat rather than the new Martin-Baker Mk. 16. Source: USAF.

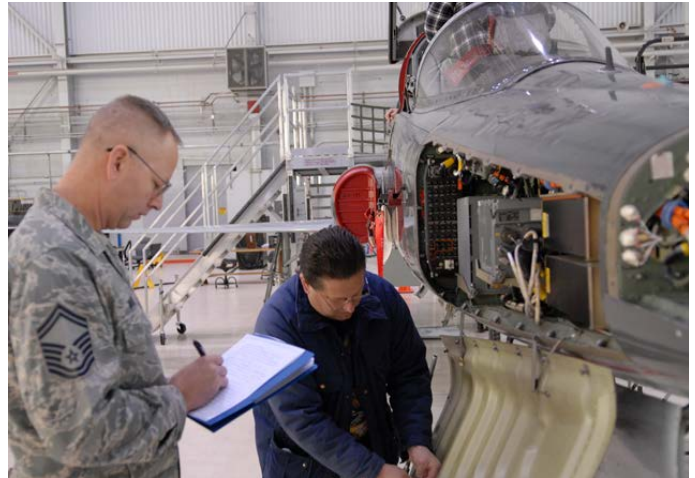
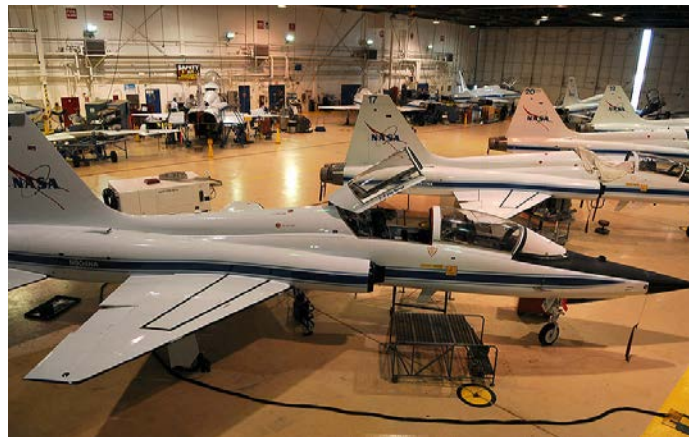
Top, maintenance being conducted on one of the USAF's T-38s. Source; USAF. Above, NASA's T-38 maintenance facility. Source: NASA.

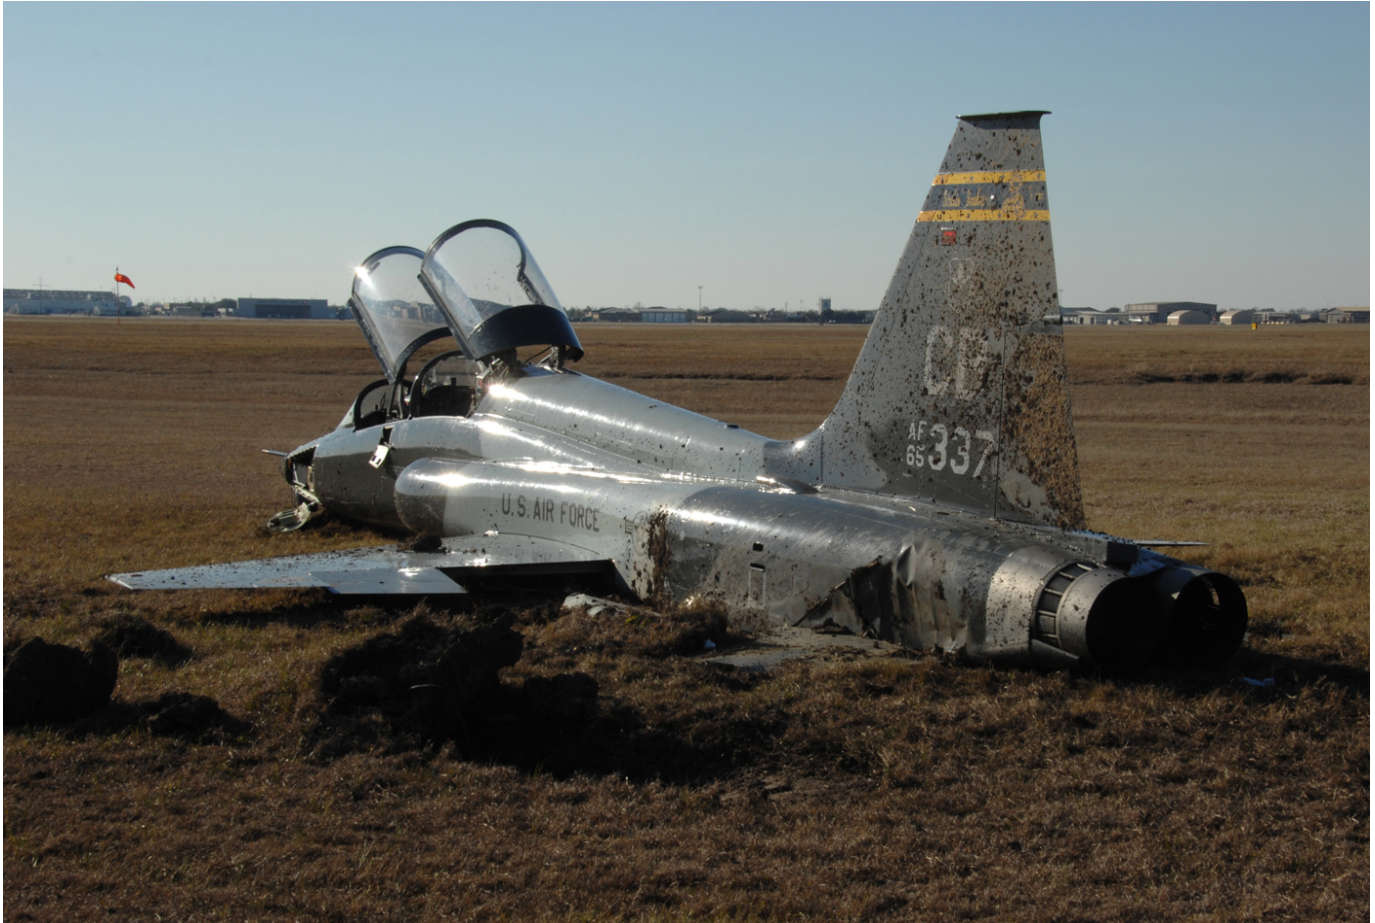
USAF T-38C accident in 2011. Source: USAF.
